Following the course of nature

DDSG MAHART Kft.

Borcea Branch

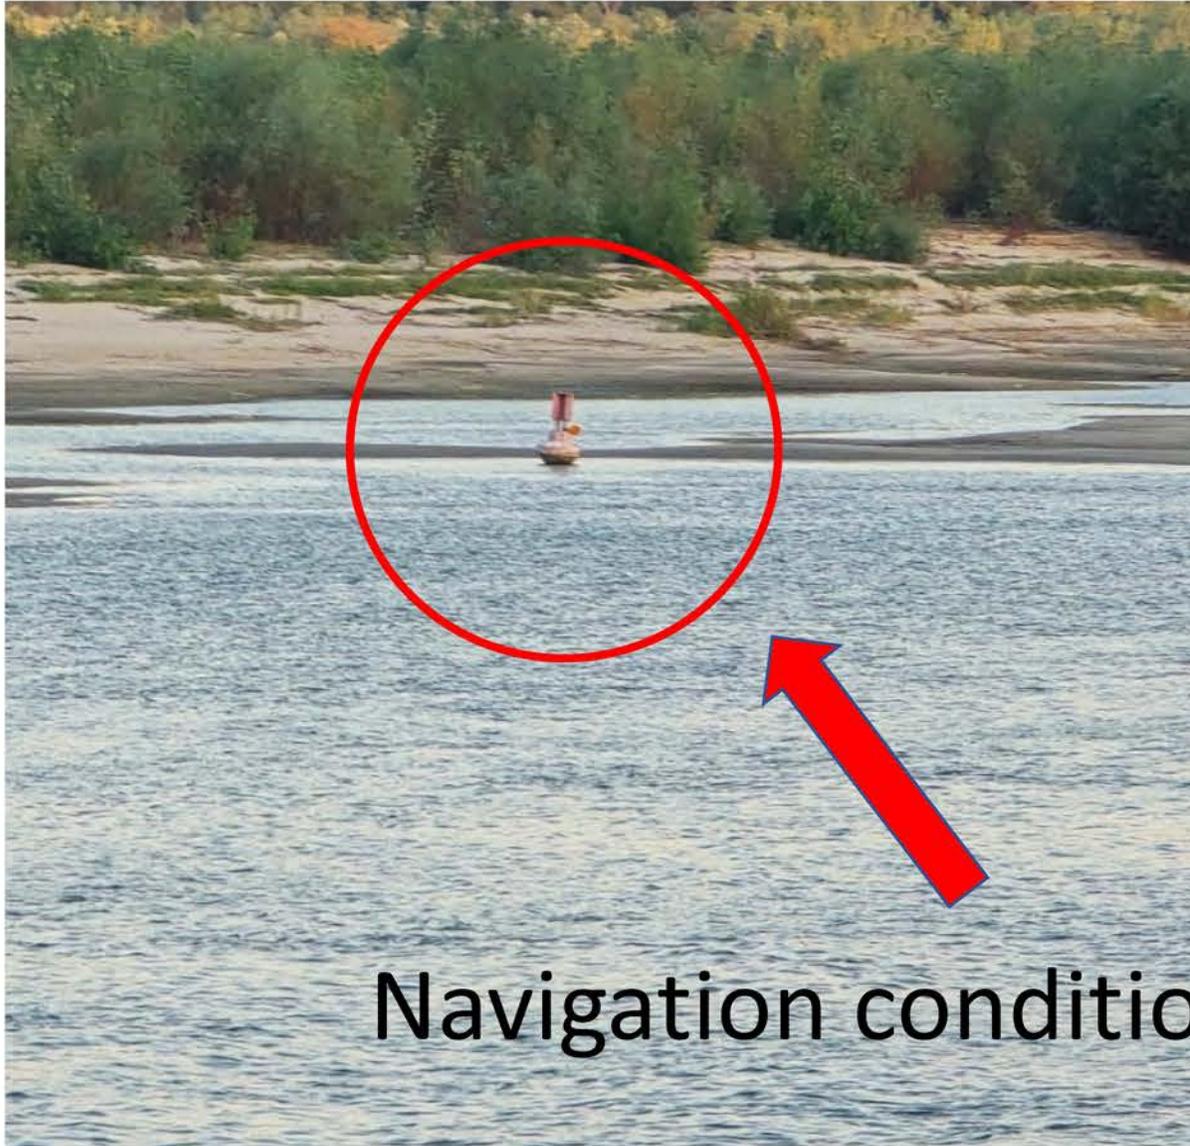
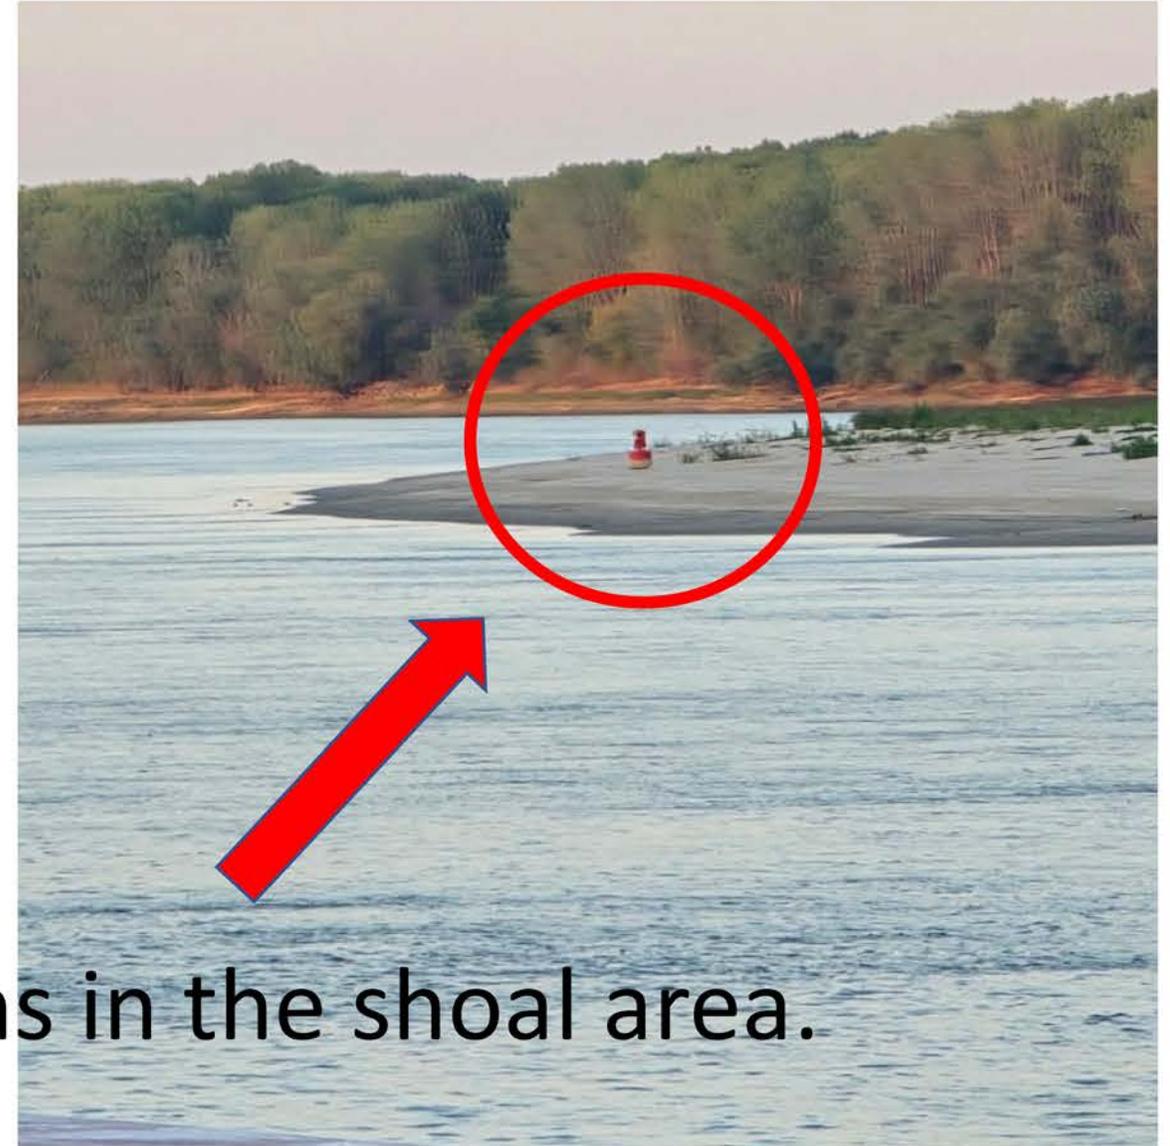
09.2025
20-24 km

Navigation conditions in the shoal area.

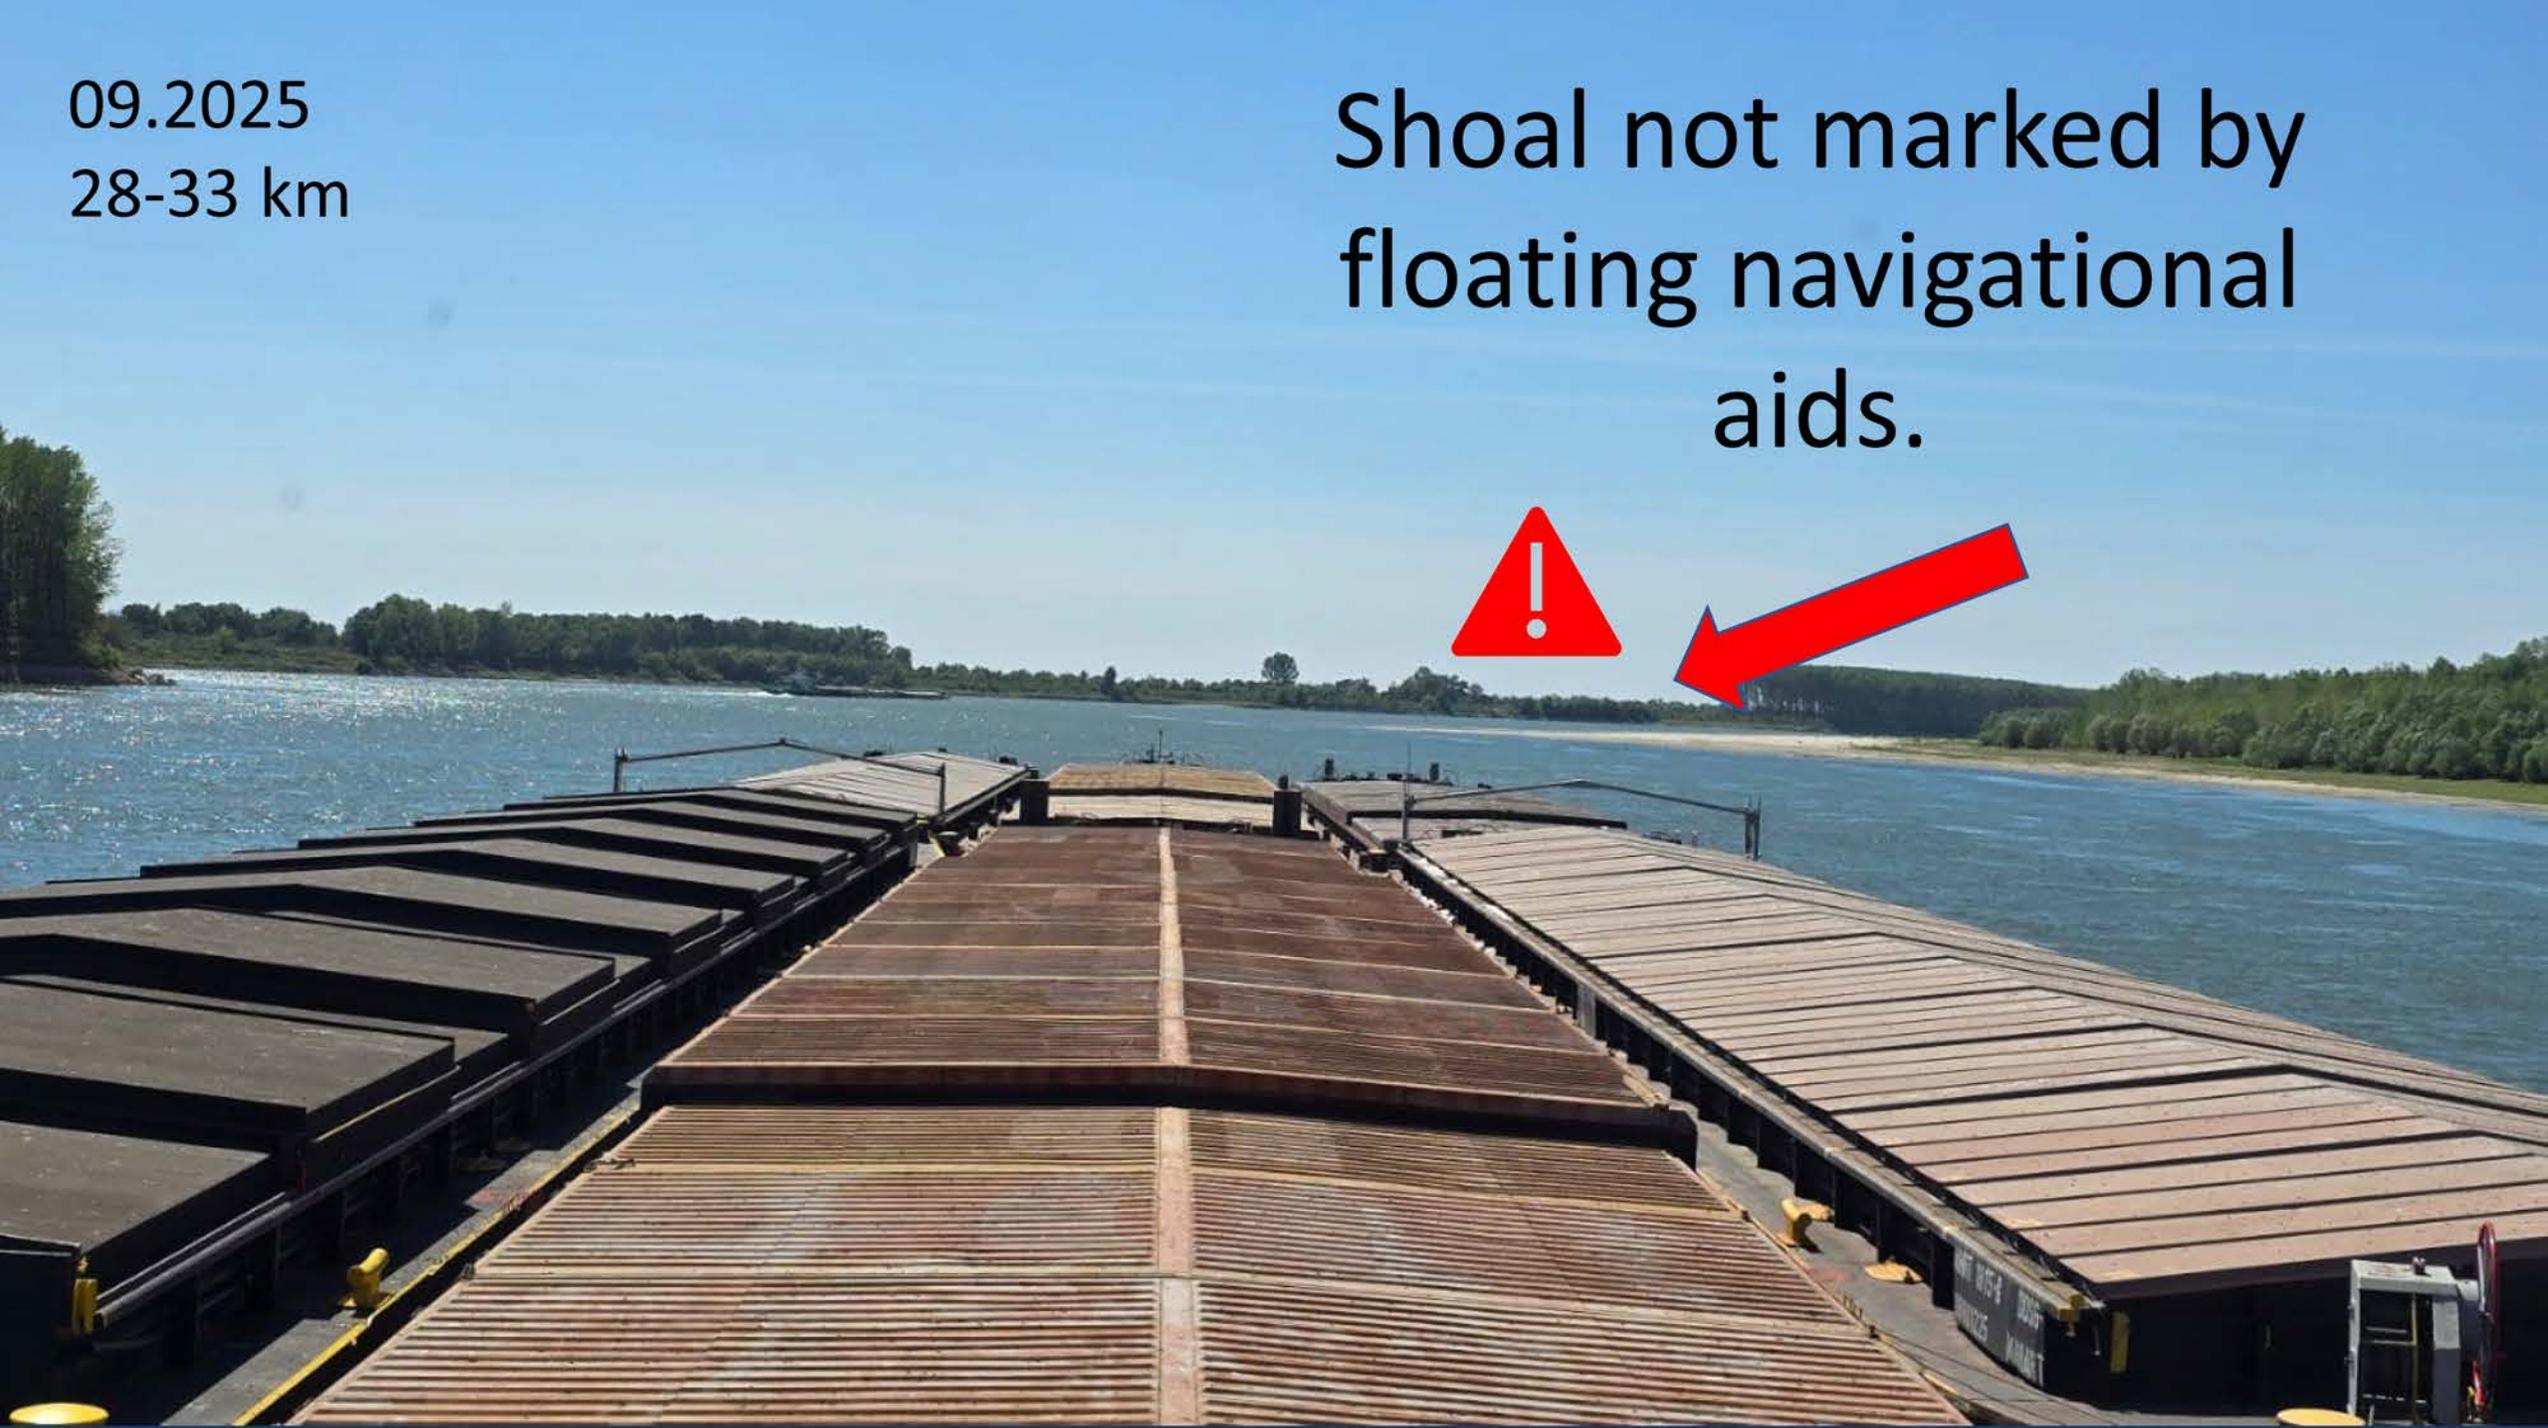
09.2025
28-33 km

Shoal not marked by
floating navigational
aids.

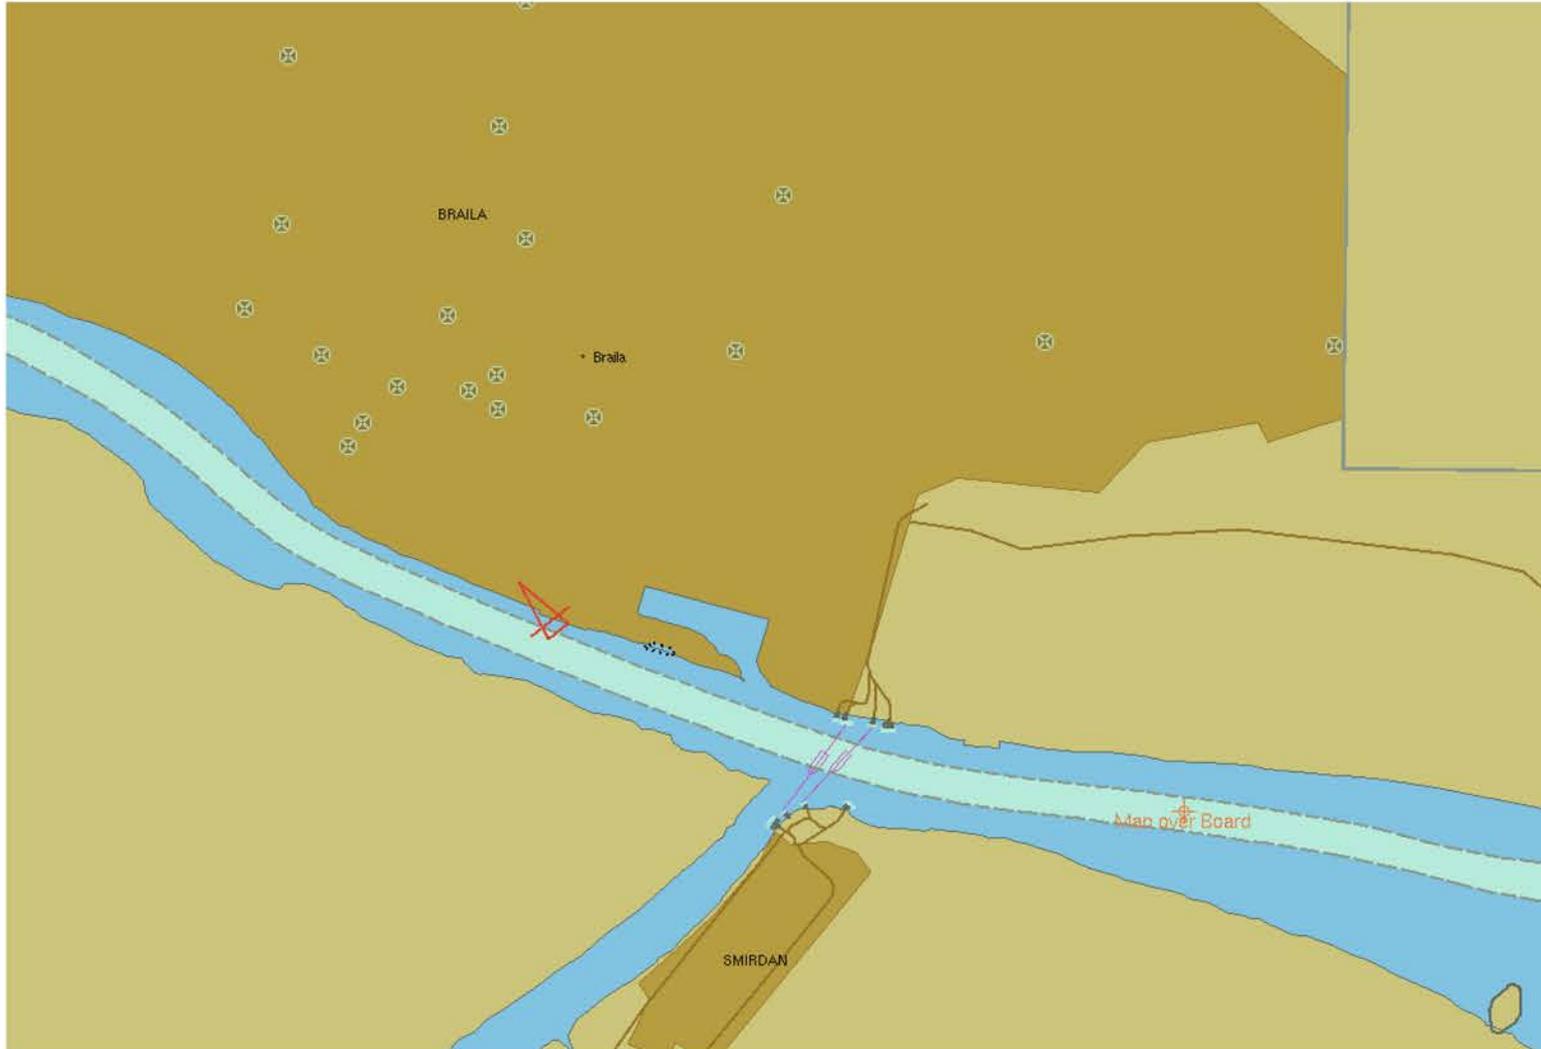
168 km
Official anchorage.

Security
issue.

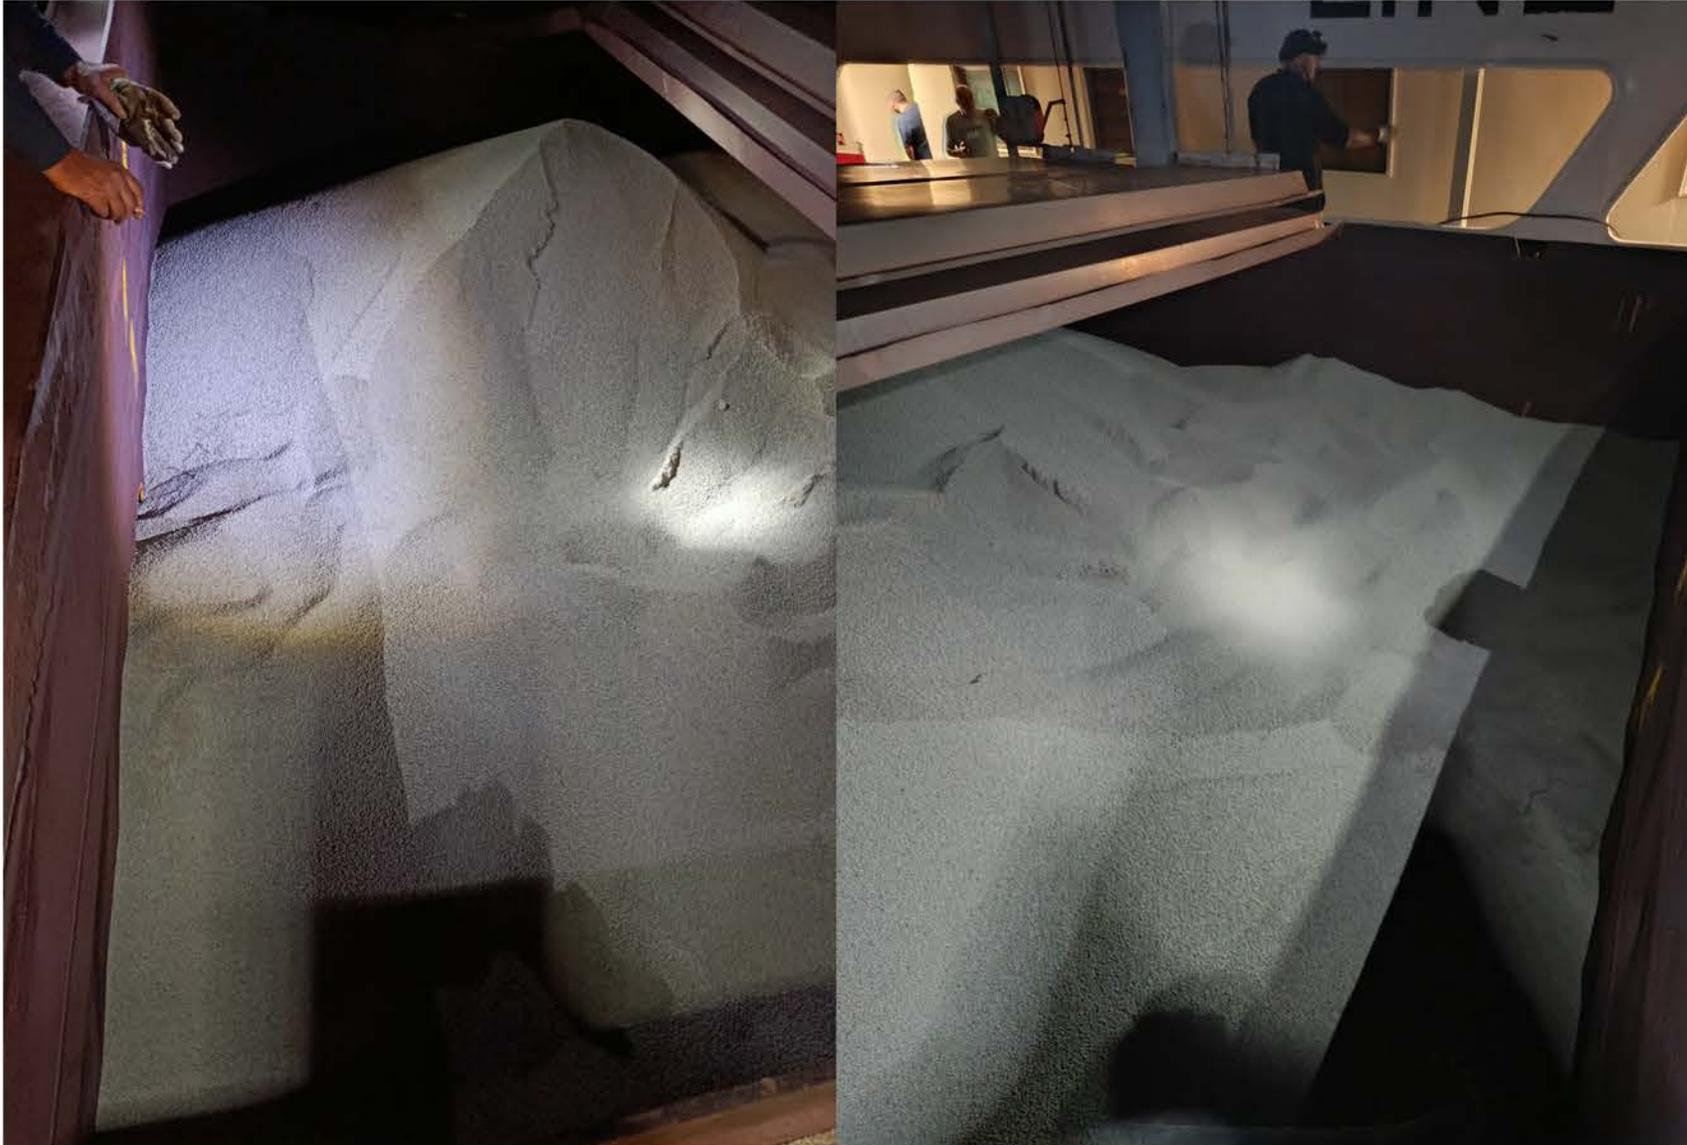
Port of Braila

Five seals were broken.

The securing cable of the hatch covers was cut.

The cargo (fertilizer) was stolen.

A report was filed with the police.
The perpetrators have not been identified.

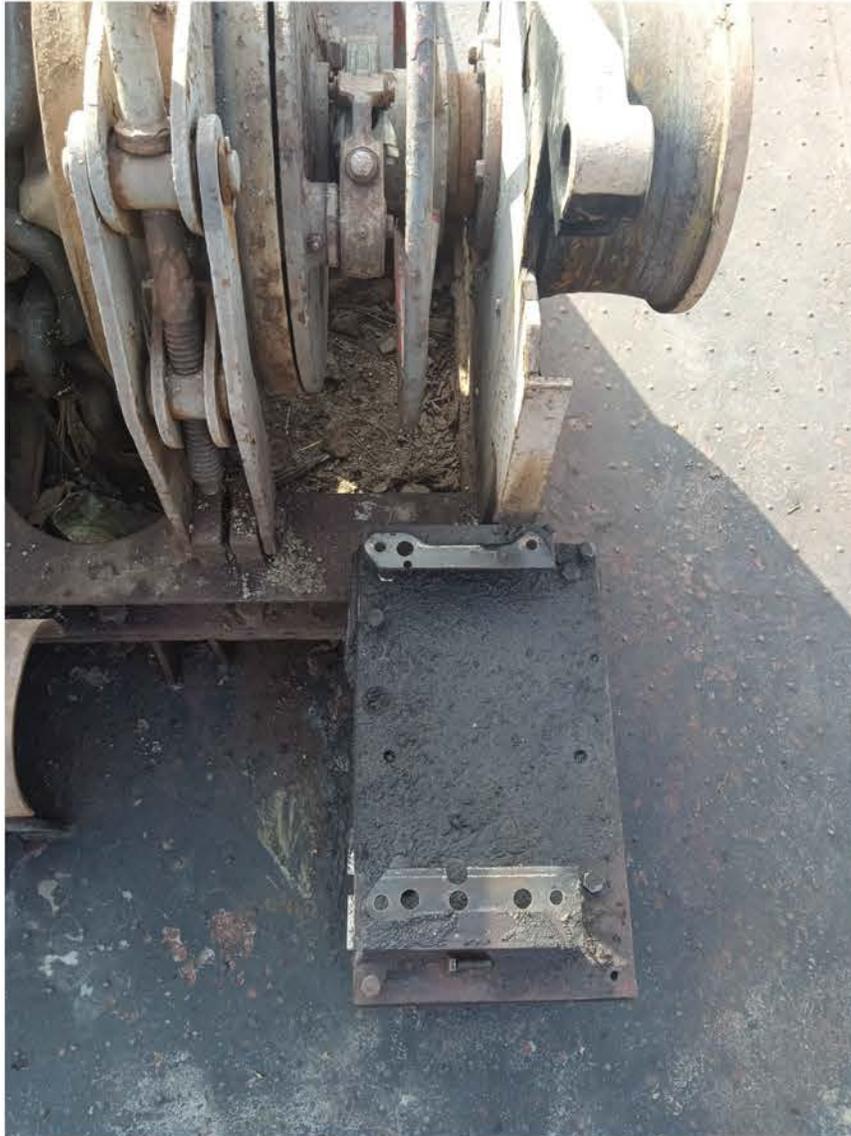
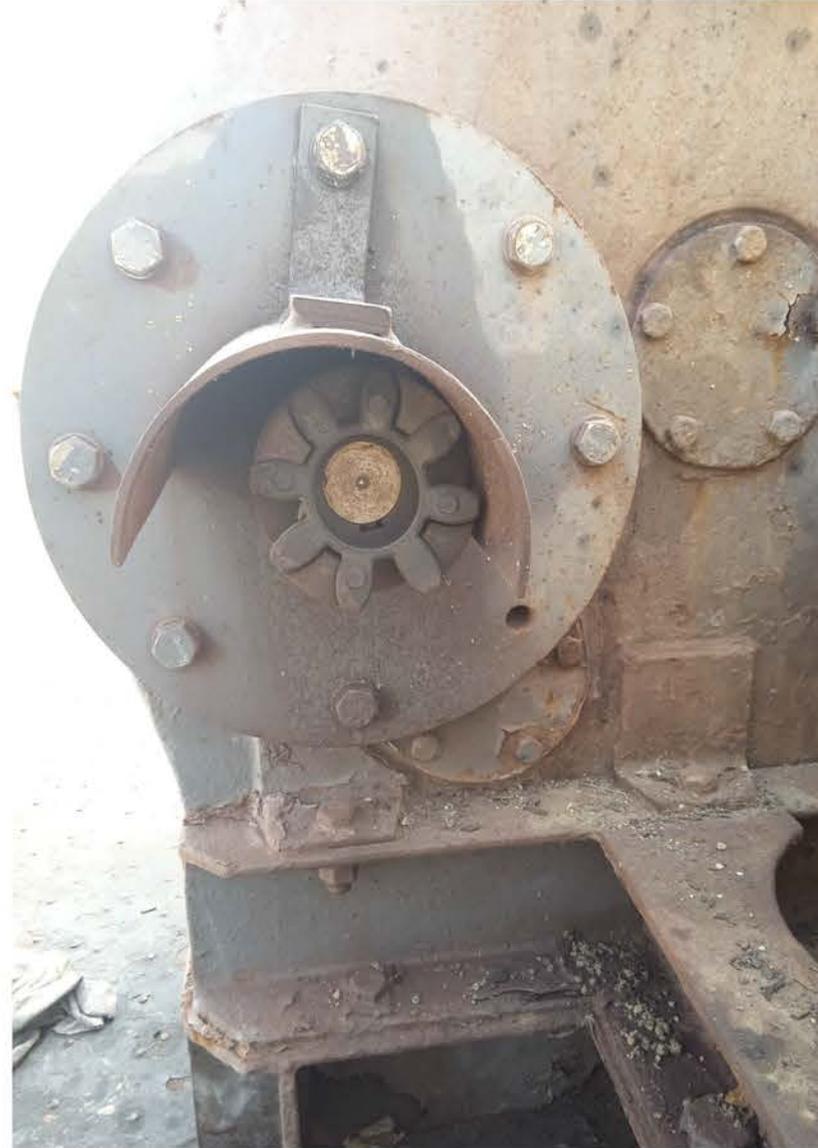
Port of Braila

Three diesel engines were dismantled and stolen from the anchoring systems of three vessels.

The weight of each engine is approximately 90 kg.

The incident was reported to the police authorities. The perpetrators remain unidentified.

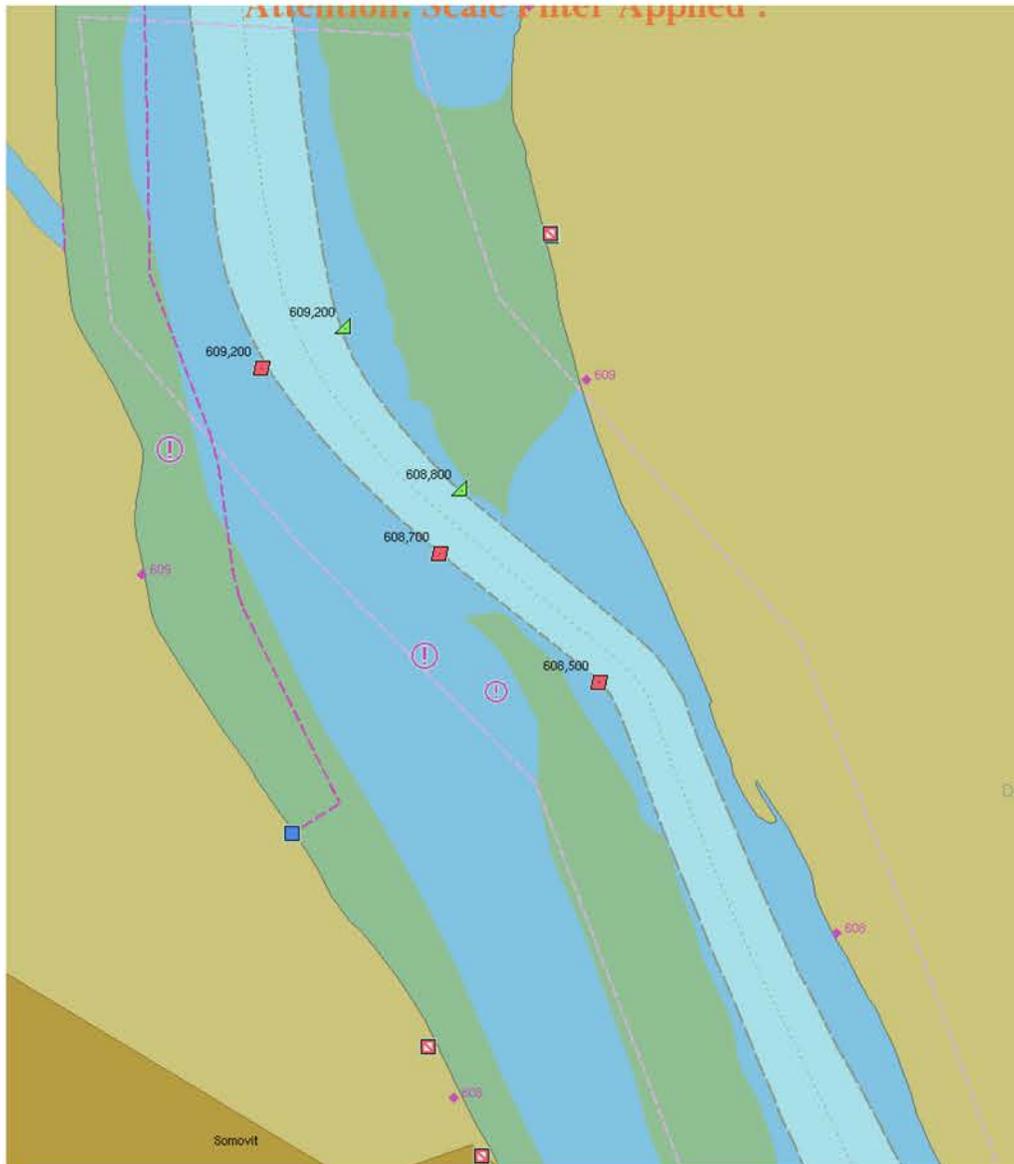
Critical section km 608–610.

Sufficient depths available.

Properly buoyed and marked for navigation.

Navigation is complicated due to the narrow fairway.

Temporary restrictions were introduced.

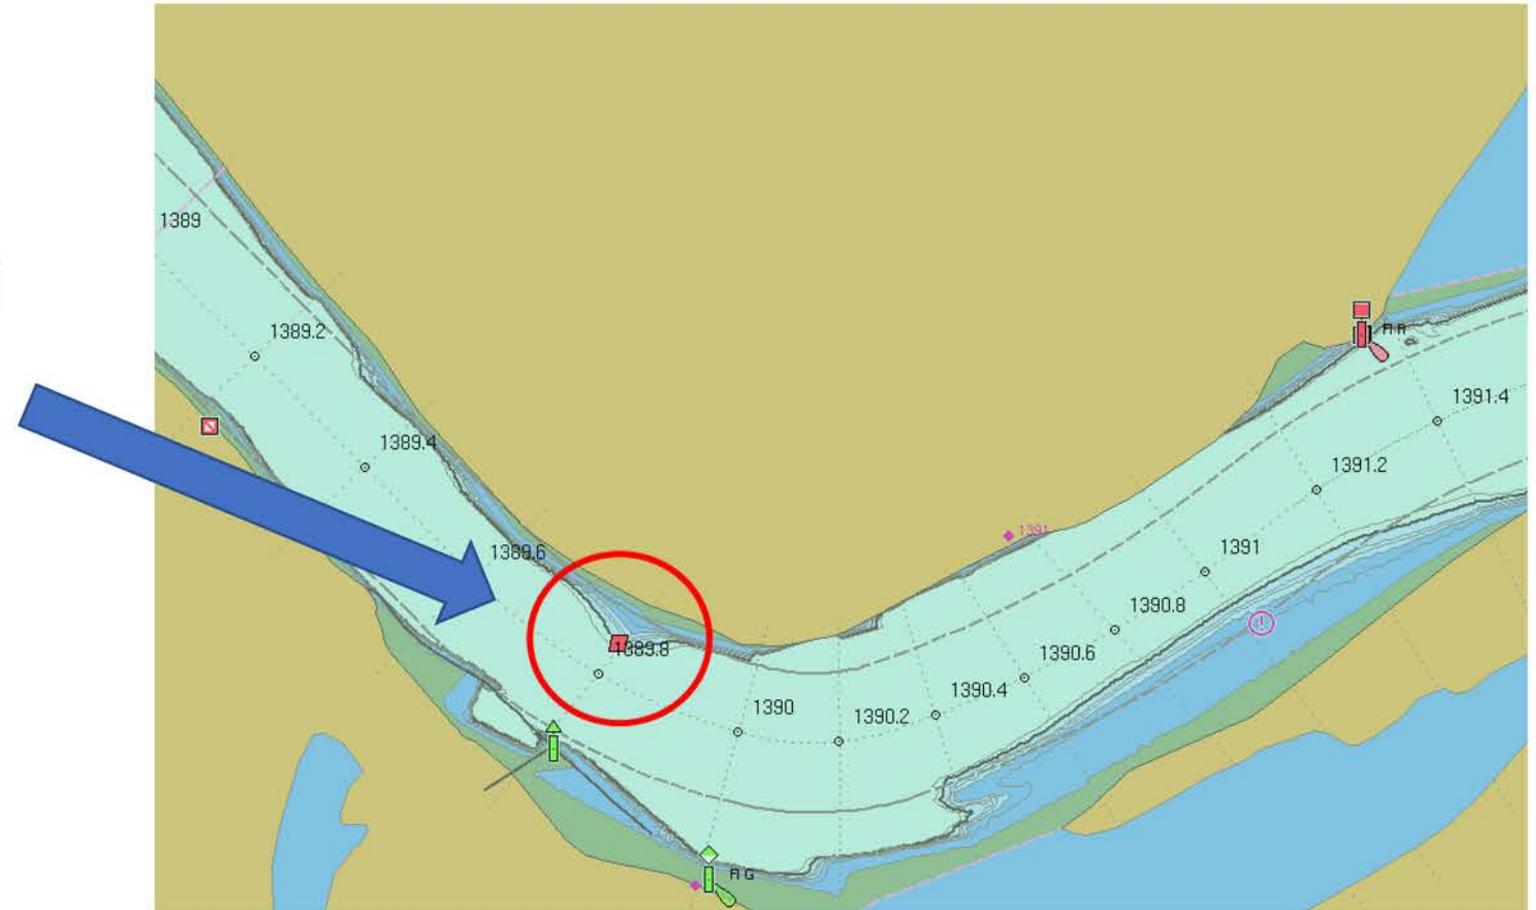
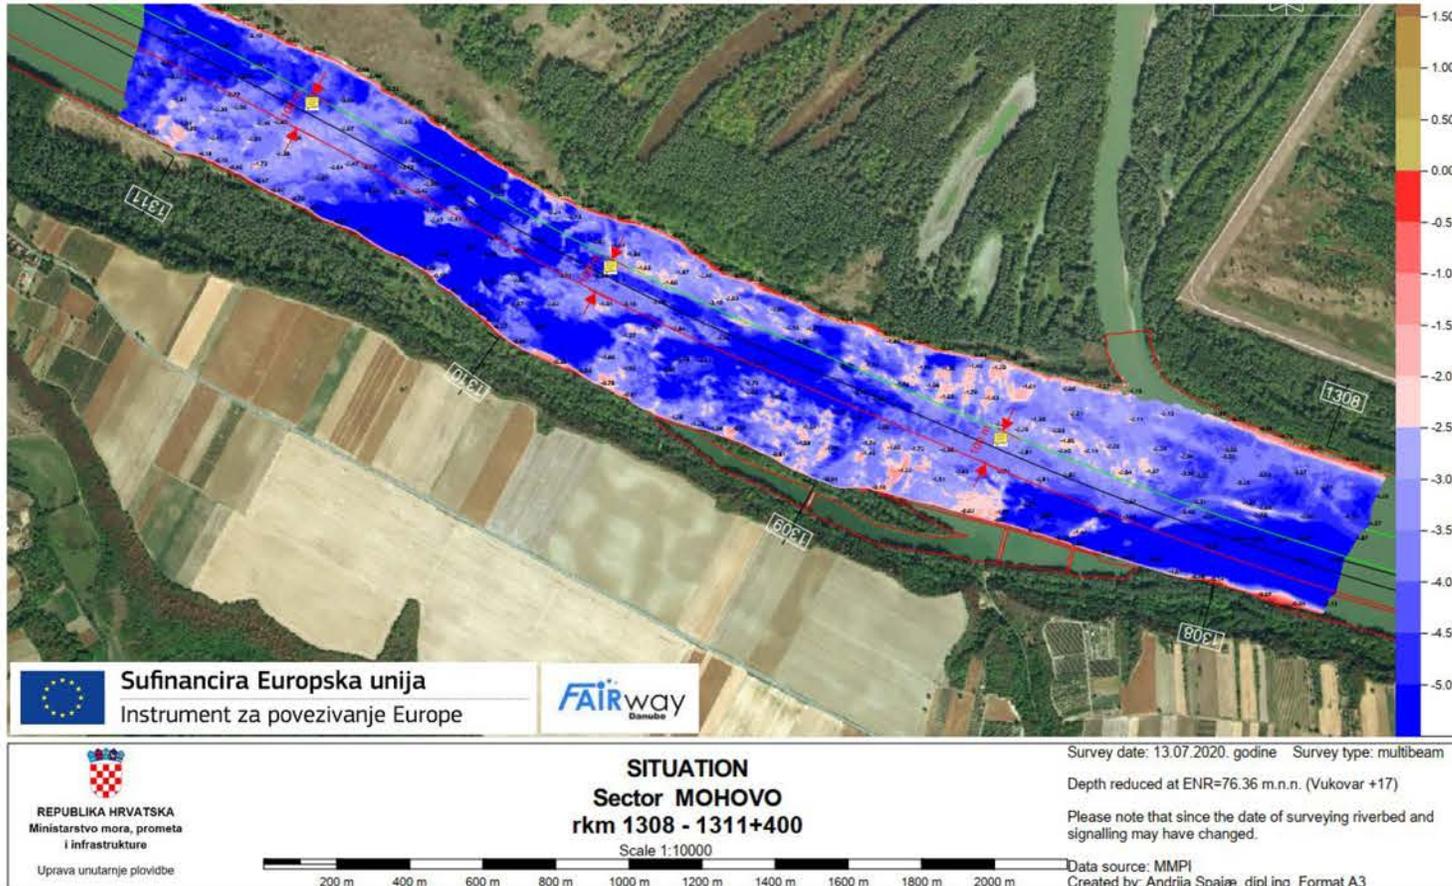
Critical section
km 1307–1311 “Mohovo”.
Latest depth survey: 2020

Actual minimum depth according to the latest official measurements at Vukovar gauge “0”: 240 cm.

Permitted draft for passing the shoal at Vukovar gauge “0”: 180 cm. Order of the Harbour Master’s Office Vukovar No. 08/2026 dated 29 January 2026

Actual safe draft for passing the section at Vukovar gauge “0”: 220 cm (based on captains’ reports).

Immediate actions required:

Hydrographic survey of the section.

Correct recalculation of allowed
navigational drafts.

Preparation of a dredging plan.

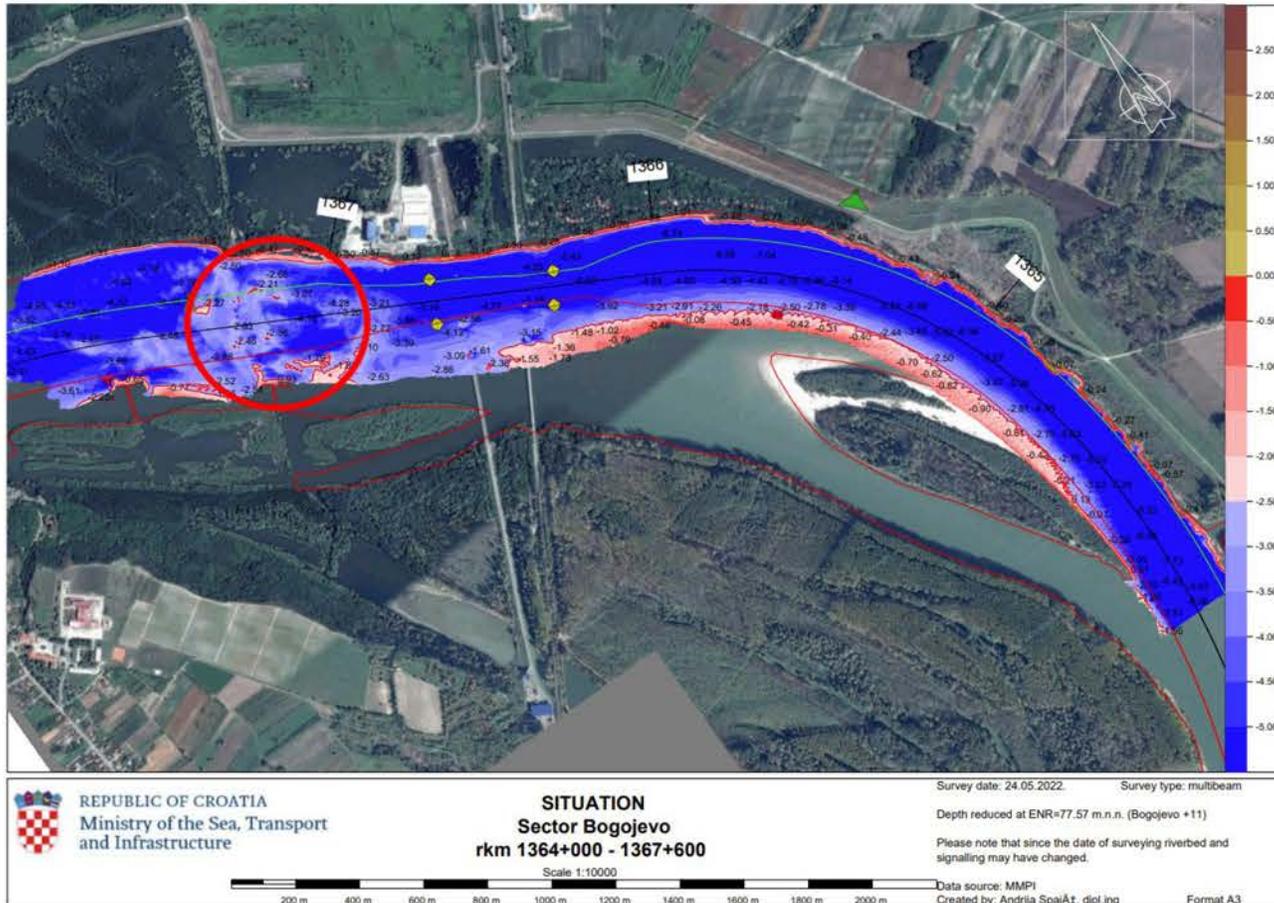
Critical section km 1367–1368 “Bogojevo”.

Latest depth survey: 2022

Actual minimum depth according to the latest official measurements at Bogojevo gauge “0”: 225 cm.
Actual depth at the shoal at Bogojevo gauge “0”: 215 cm (based on captains’ reports).

Immediate actions required:

Hydrographic survey of the section.

Preparation of a dredging plan.

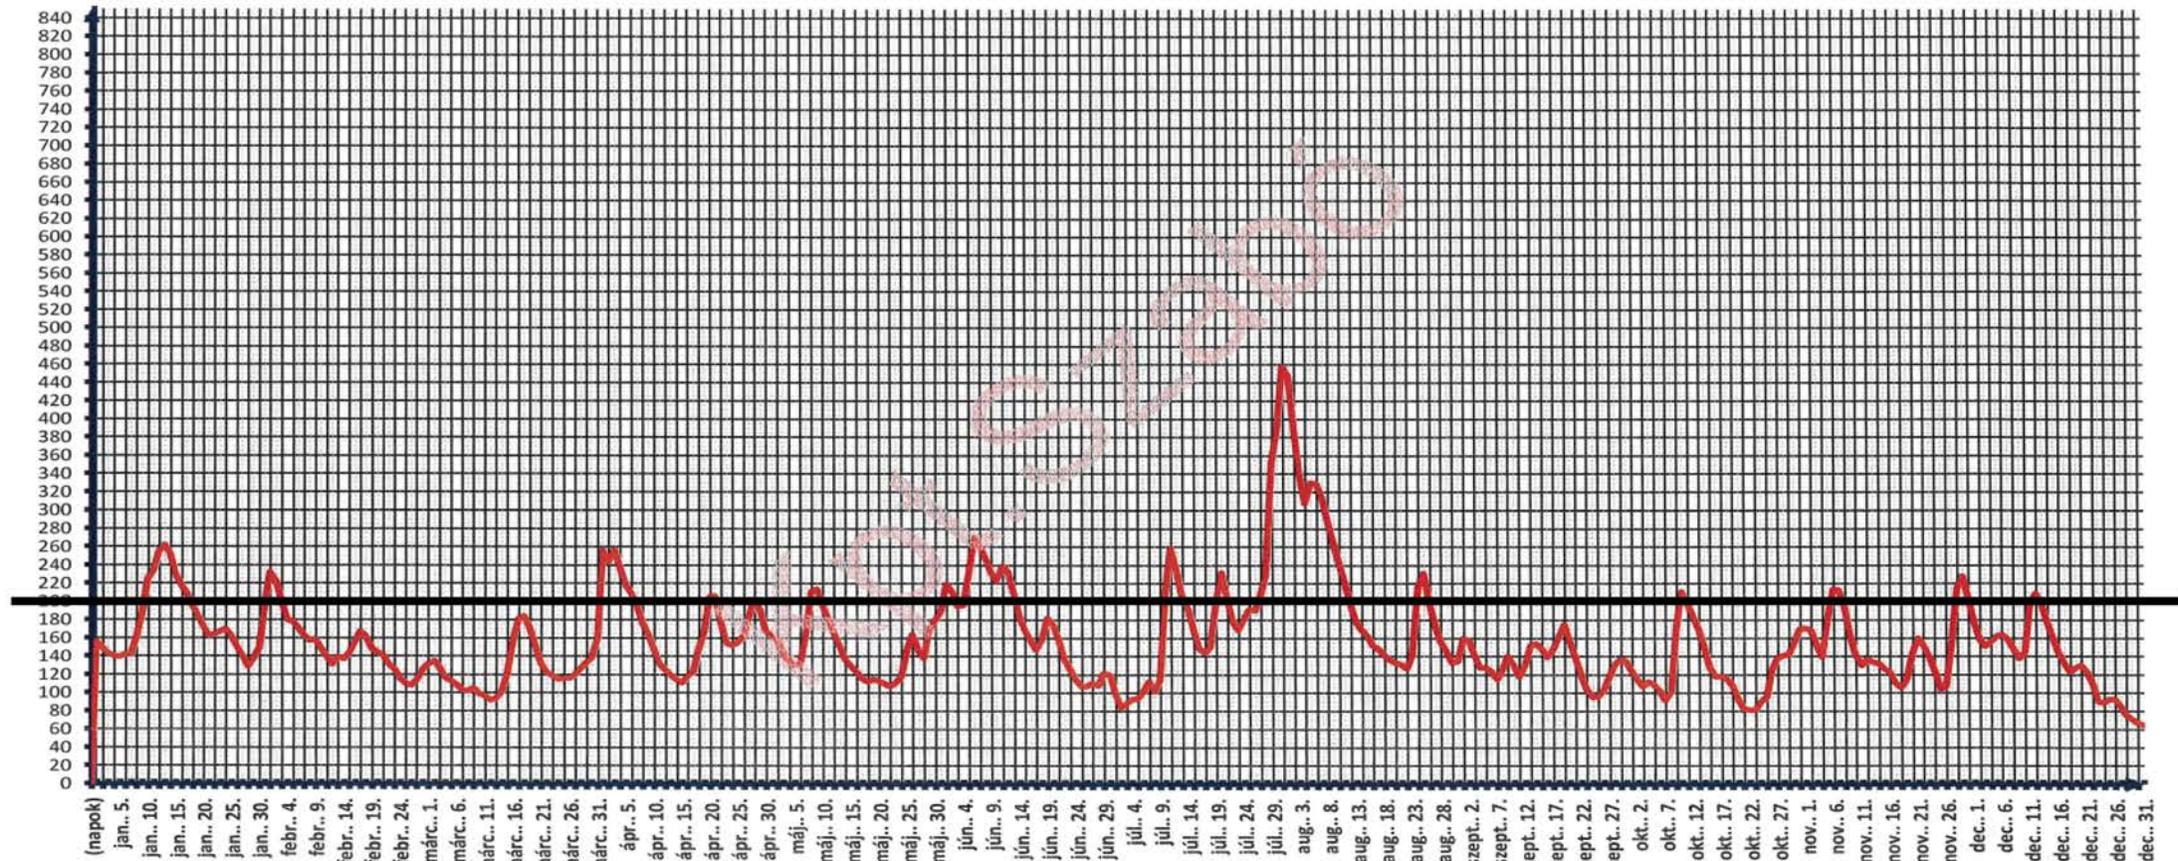
BUDAPEST - 2025

In 2025 the water level at the Budapest gauge remained below 200 cm for 301 days.
