Review of fairway conditions on the Danube in 2025

Iris Marstaller | Joint Workshop of EUSDR/PA1a and the Danube
Commission | 04 March 2026

Status of fairway conditions in 2025

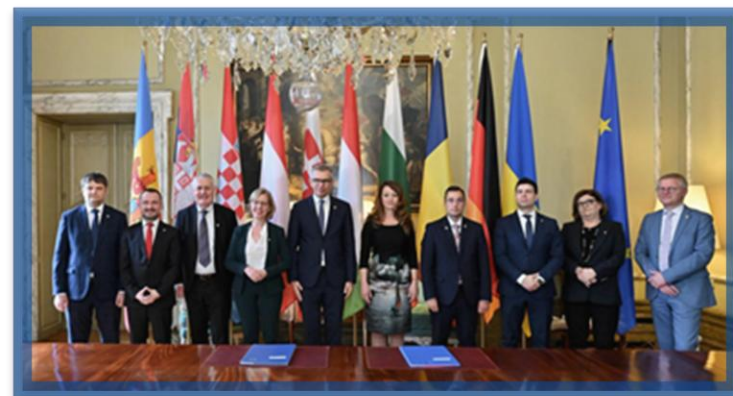
Fairway Rehabilitation and Maintenance Master Plan
– Danube and its navigable tributaries

Fairway Rehabilitation and Maintenance
MASTER PLAN
for the Danube and its navigable tributaries:

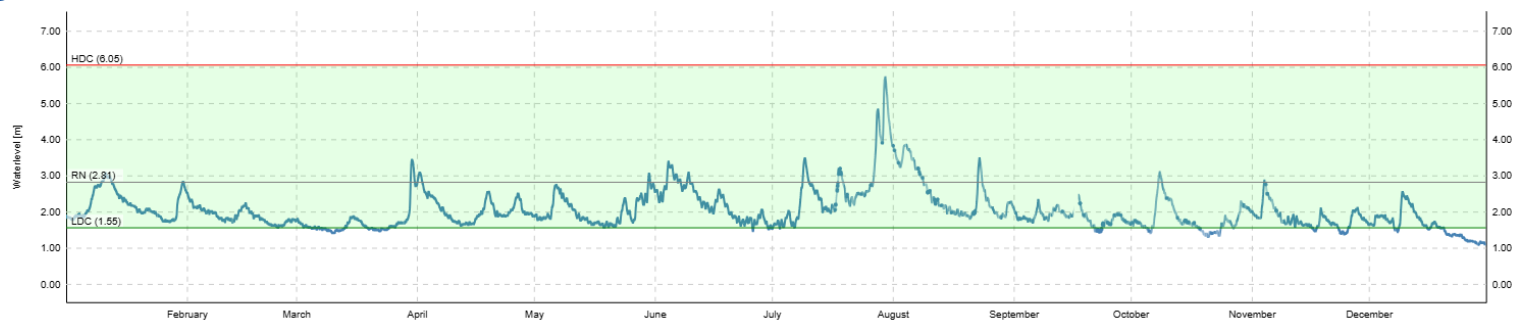
Upper Danube
(Wildungsmauer)

Hydrological conditions 2025

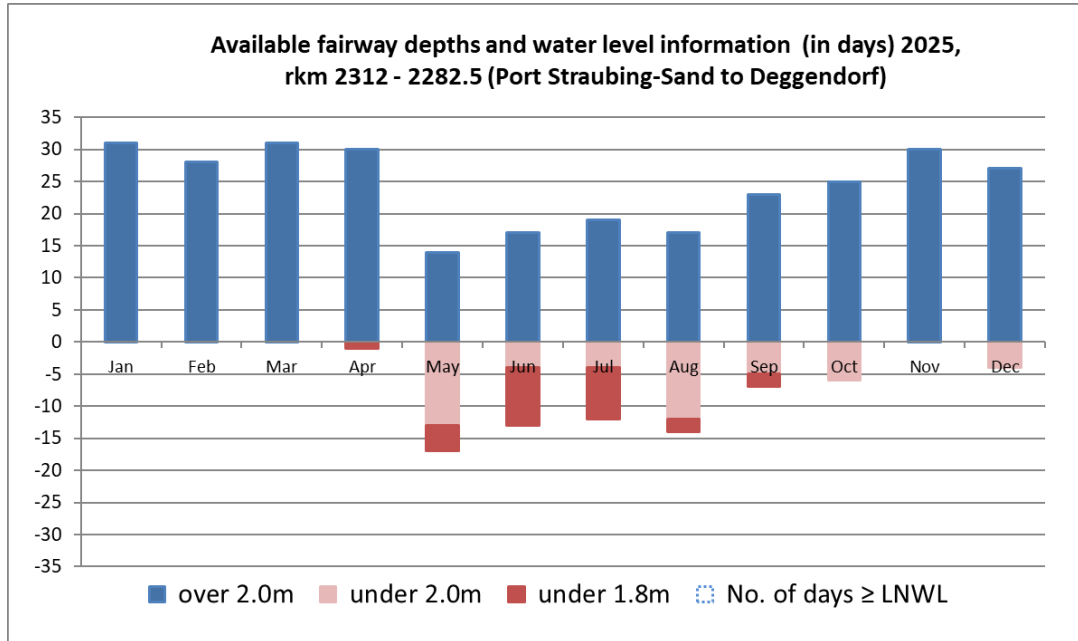
Upper Danube – Germany

German critical sections suffered throughout the year from low water – especially from May-August

- 266 surveying activities
- 28 dredging interventions mainly in the second half of the year (ca. 100.000 m³)

! In the free-flowing section between Straubing and Vilshofen the current objective is to maintain the fairway depth of 2.00 m related to LNWL

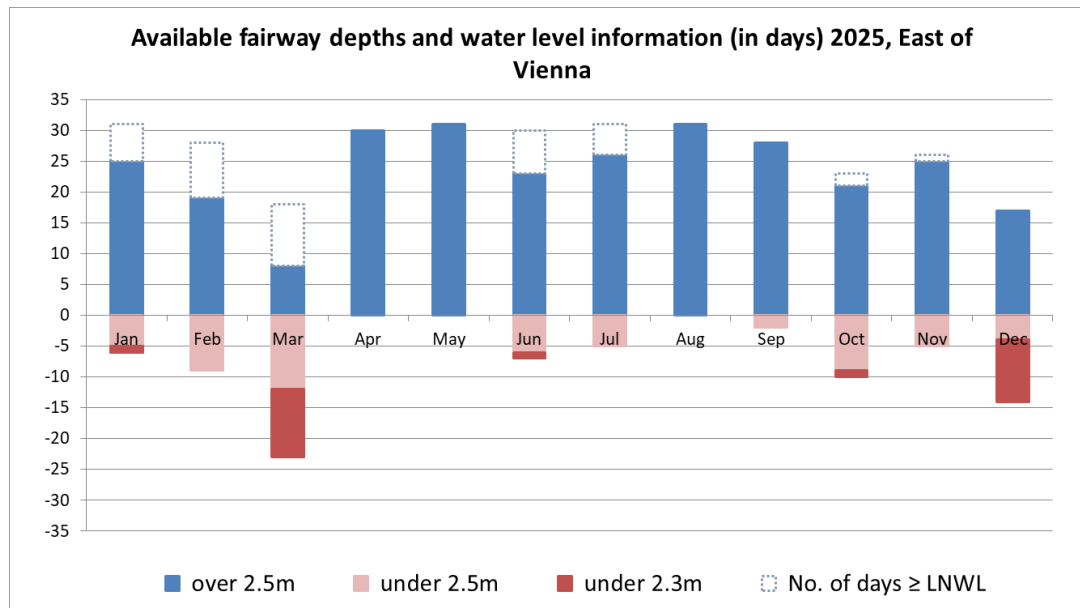
Upper Danube – Austria

Austrian sector east of Vienna was more challenging than the previous years, with 51 days below 2.5 m fairway depth.

- Early 2025 operations focused on cleanup from September 2024 flood and prioritized dredging due to limited equipment availability.
- much lower discharge than in 2024, with frequent low-water periods, throughout the year
- Navigation continued throughout, but fairway depth targets of a normal year were not fully achieved.

- Total dredging volume: 462.283 m³

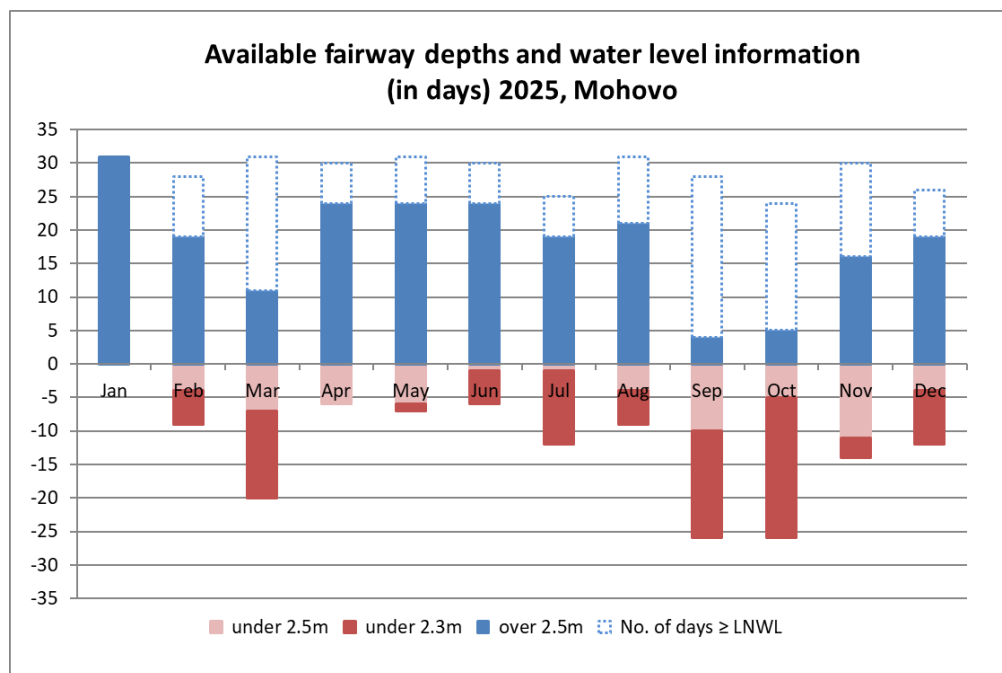
Central Danube - Croatia

Mohovo with a 148 days below 2.5 m fairway depth (for full fairway width of 100m) - also suffering from below average discharge.

- 10 surveying tours (Danube)
- 400 marking tours
- dredging on Sava and Drava 78.555 m³
- No dredging on Danube in 2025
- Difficulties during LNWL for navigation on Sava – dredging in two locations

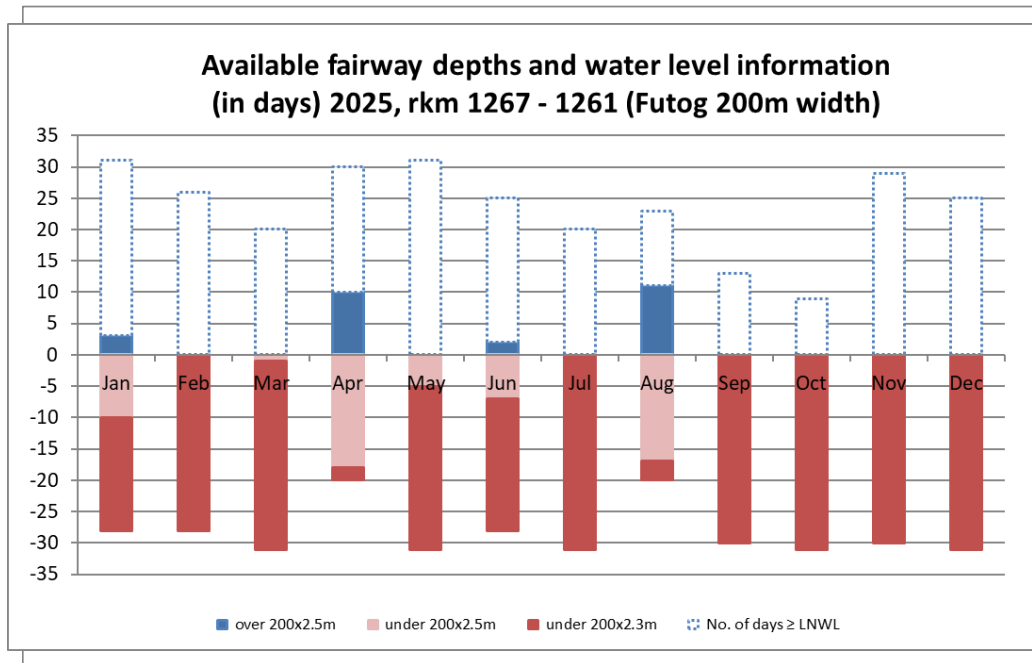
Central Danube - Serbia

Fairway availability at the critical section Futog through adaptive management, including reducing the width to 150 m.

- 58 surveying tours (Danube)
- 154 marking tours
- 73 days below LNWL – navigational limitations in July
- Fairway availability achieved through
 - Temporary width reduction
 - Fairway relocations and route adjustments
- Dredging at Čortanovci: ca. 137.000 m³

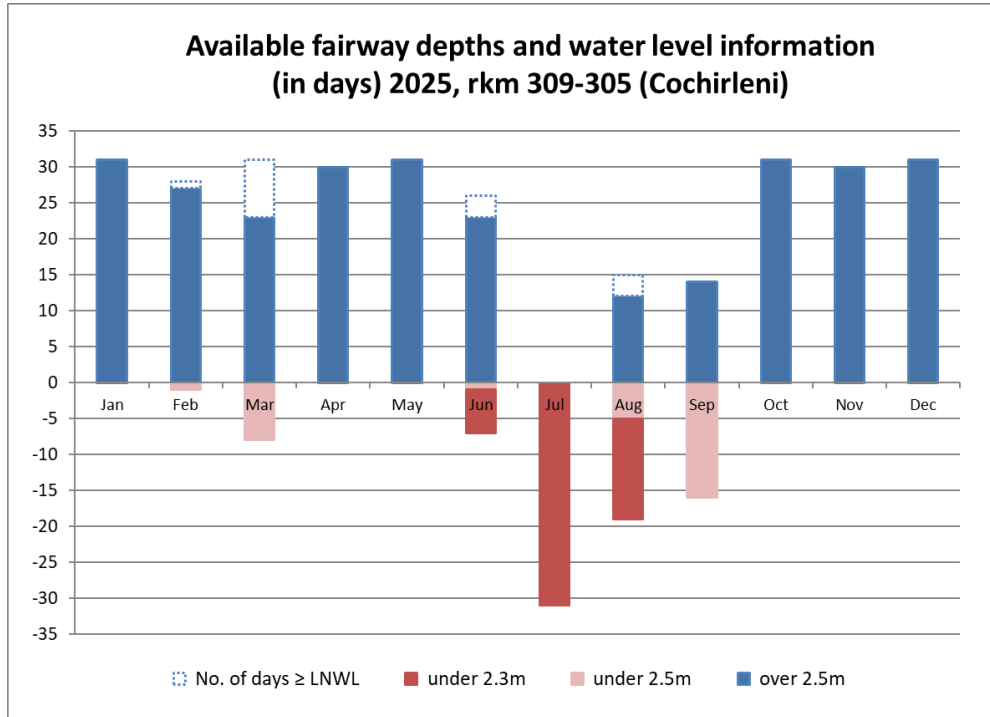
Lower Danube - Romania

Lower Danube faced extreme low water in the summer months. 102 days below LNWL at gauge Cernavoda.

- AFDJ issued warning in June to all traffic participants regarding extensive low water
- 242 surveying tours (entire sector)
- 65 marking tours
- Dredging interventions
 - river Danube: ca. 1.080.000m³
 - maritime D.: ca. 350.000 m³
- Dredging framework contracts valid until end of 2026 with a volume of 900.000 m³/year

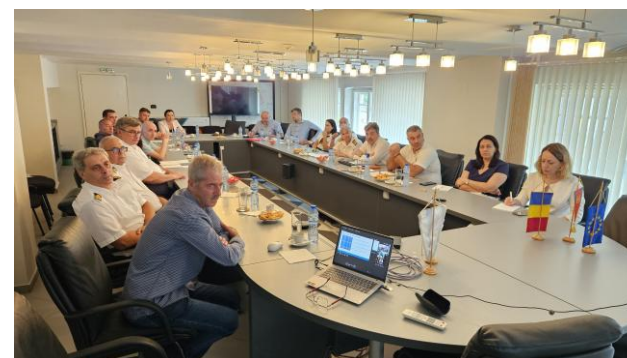
Additional efforts made by APPD and AFDJ to ensure good fairway conditions during low flow events – example of good practice for waterway-management

- From June until October 2025 exchanged daily information
 - with captaincies about minimal depth in the critical sectors
 - which then informed the shipping companies
- Organisation of two stakeholder events
- Helped to decrease the number of grounded vessels
