Following the course of nature

DDSG MAHART Kft.

Borcea Branch

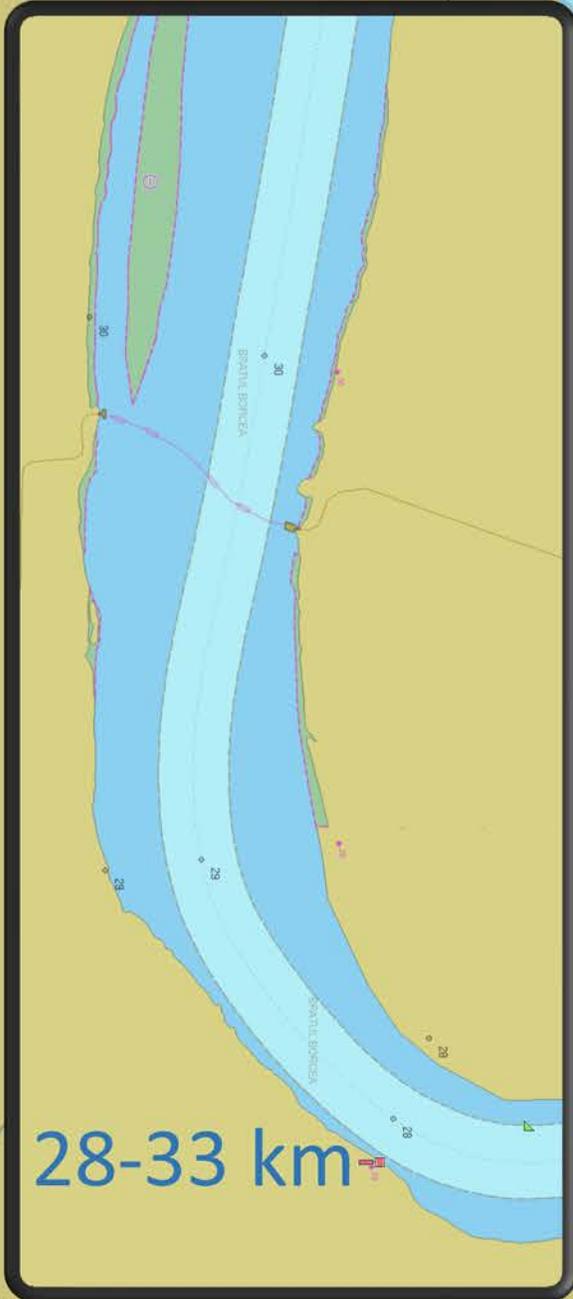
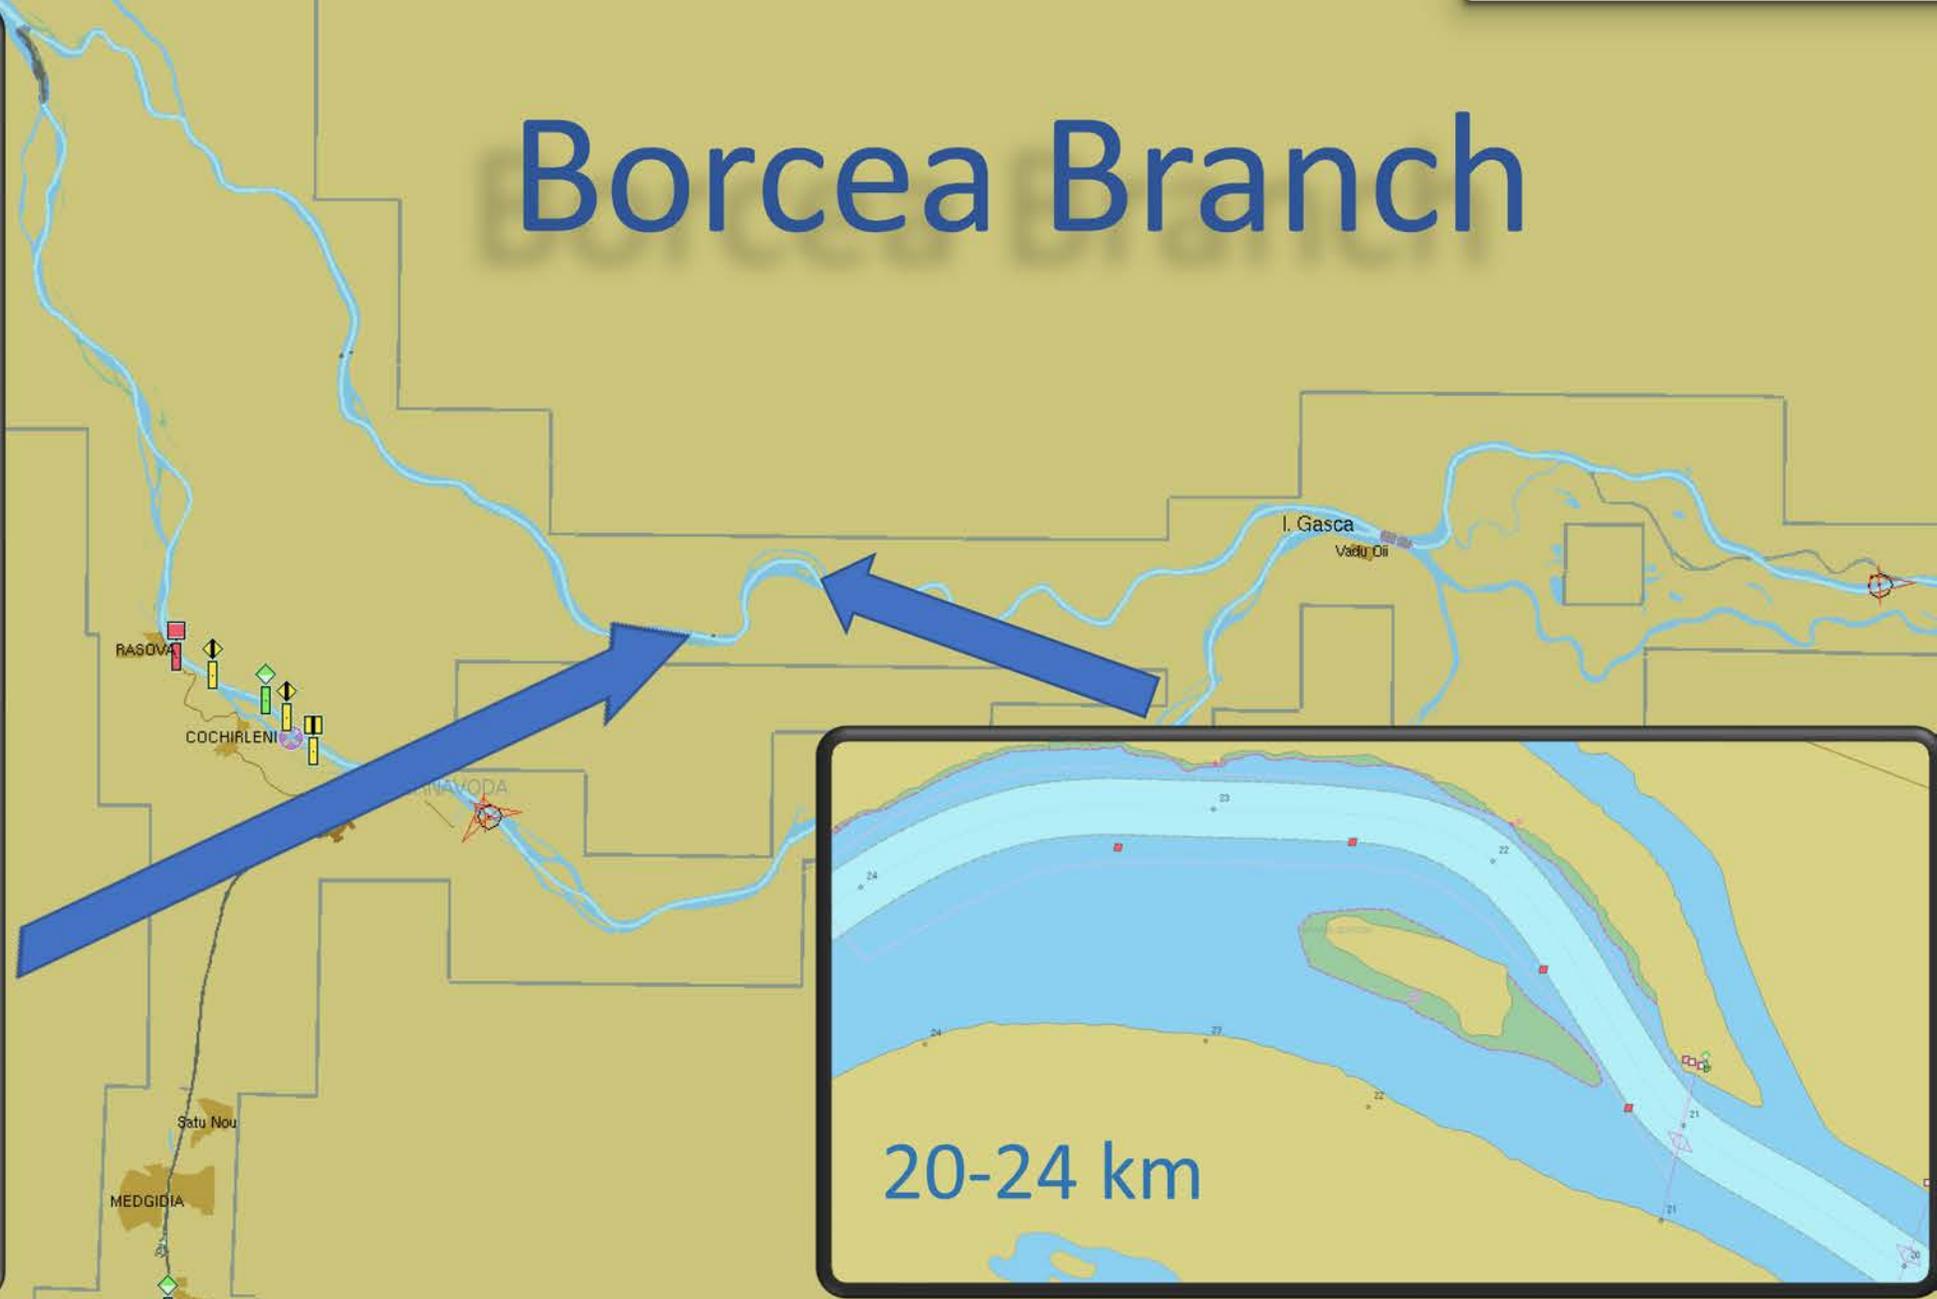
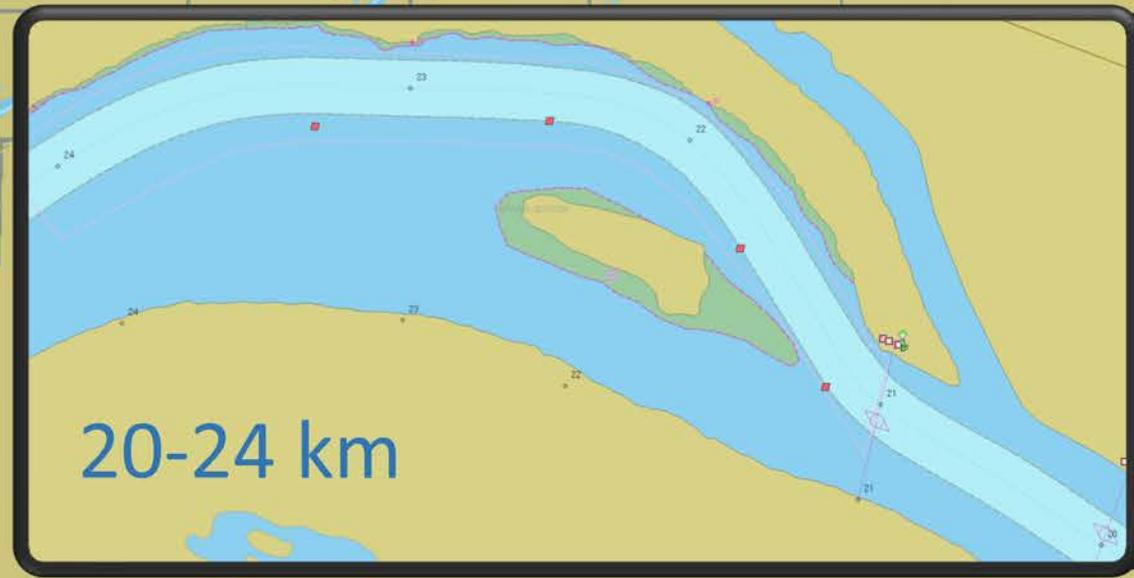
09.2025
20-24 km

Navigation conditions in the shoal area.

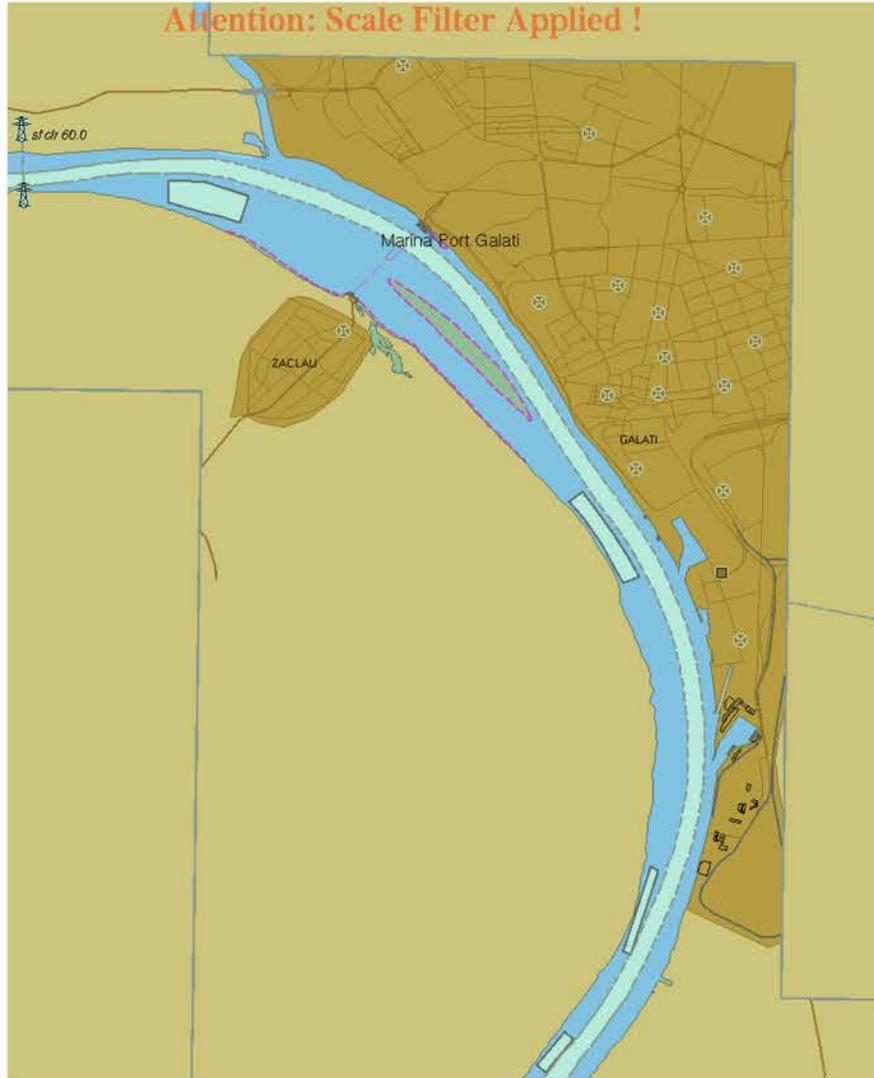
Waiting time for inspection and completion of clearance formalities (12–24 hours).

For comparison: in the ports of Turnu-Severin, Veliko Gradište, Bezdan and Mohács, clearance procedures operate 24 hours a day and usually take no more than four hours.
